THE
Aeolian-Skinner
Organ

Calvary Church

MEMPHIS, TENNESSEE

Site survey conducted 15-17 April 2001
Draft report submitted 10 October 2001
Final report submitted 31 October 2001

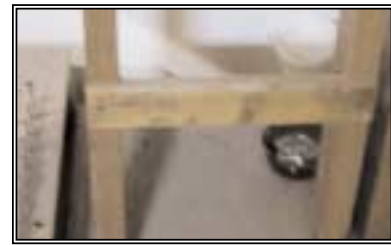
ashtray next to lower Great windchest

Highly disturbing is the presence of ashtrays and cigarette butts, particularly in an object made from dry, aged California sugar pine covered in orange shellac: a textbook tinderbox. Smoking is strictly forbidden.

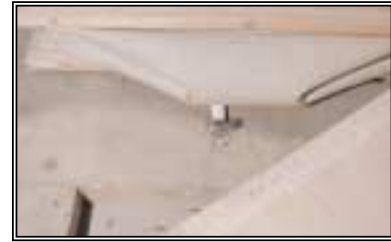
cigarette butt, under disused Great winker

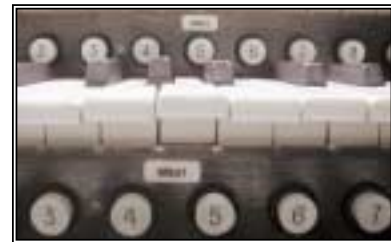
very uneven keys, Great manual

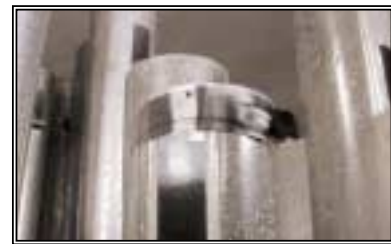
Swell pipe "repaired" with tape

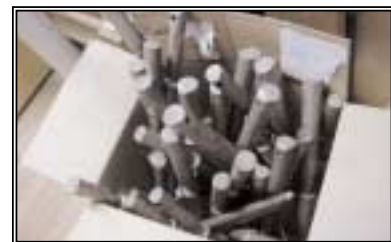
Swell Vox Humana, haphazard storage

The two most pressing pipework needs are the Trompette-en-chamade and the Vox Humana. The Chamade's poor chest installation is compounded by inadequate racking; several of the pipes are collapsing of their own weight. The Vox Humana is stored in a cardboard box. This stop is probably beautiful; at the very least the pipes should be stored in a proper tray until a new windchest can be built and installed.

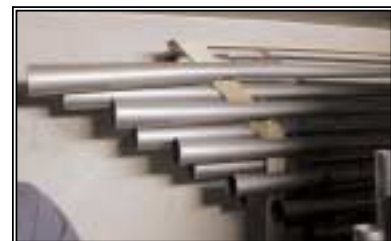
horizontal trumpets, bending under pressure

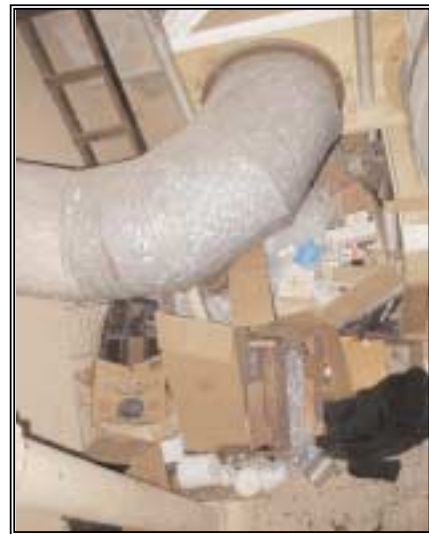
The blower environment is poor, primarily because the room is being used as a junk pit. All manner of foreign items are stored here. An excellent first step would be to clean out the junk pile, then perform a thorough vacuuming and damp-wiping. After cleaning, a filter could be fitted to door intake, to ensure that the organ breathes clean, dust-free air.

ABOVE
blower room junk

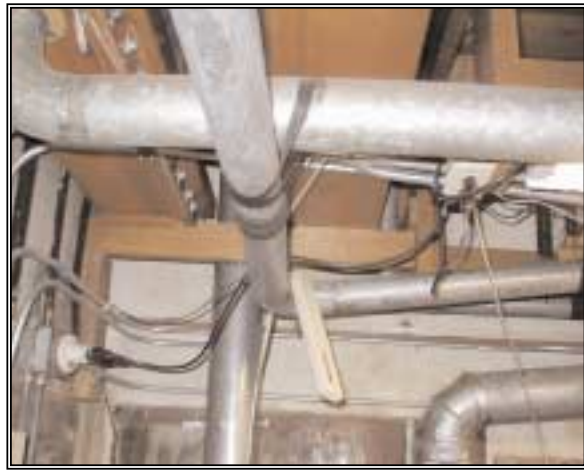
an example of sloppy 110-VAC wiring in the South chamber

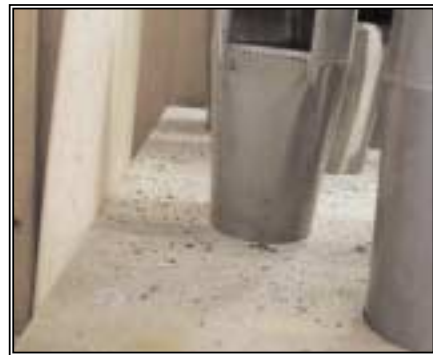
particulate dirt on the elevated Swell chest

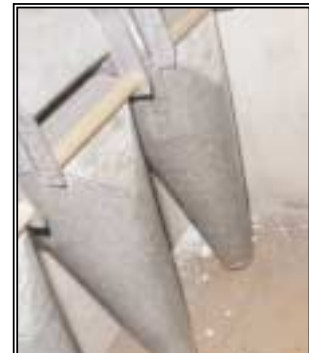
plaster dust in Choir

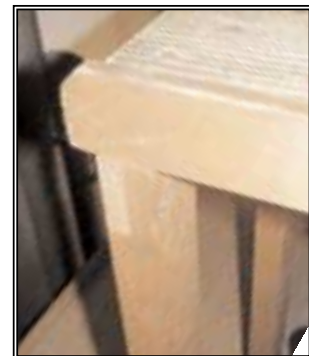
Once inside the organ, access is generally easy to all divisions. Certain methods of access require improvement. The step just inside the North chamber door is flimsy, and should be replaced with a new one. The ladders, walkboards and perchboards are worn in places and could use review and renewal. An extra grab-handle here and there would make the technician's journey a surer one.

flimsy perchboard in upper Swell

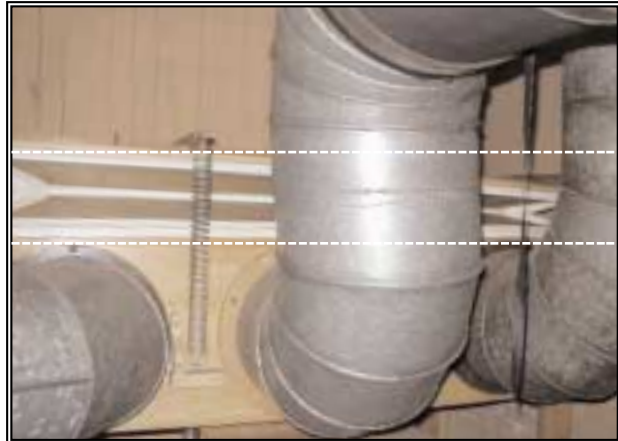
main static bellows (note unevenly rising top)

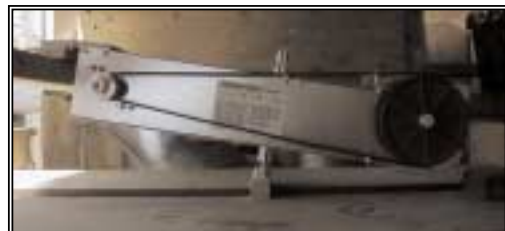
replacement electric inertia tremolo unit in the Choir

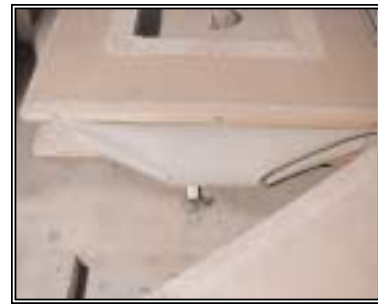
CONCUSSION BELLOWS: These units absorb shock in the wind system to prevent shimmy and jiggle. There seems to have been a concussion bellows fitted to the Great organ originally. It has been disconnected and is lying beneath the lower-level Great windchest.

Great concussion bellows

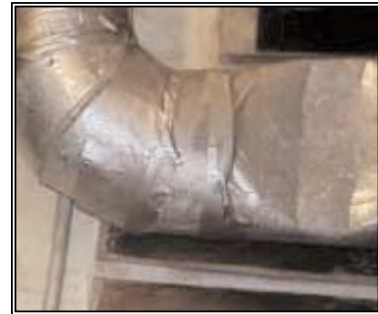
DUCTS: Although much of the ductwork is in decent shape, there is evidence of considerable trauma. Many smaller sections of duct require repair or replacement. Leaks have been patched with duct tape, which (despite the word) is no match for proper repair. Also, there are leaks at flanges that should be diagnosed and tightened, although the problem may be that the gasket leather on the flanges has failed. Diagnosing and remedying these leaks should make the organ quieter.

Swell duct: badly damaged, poorly repaired

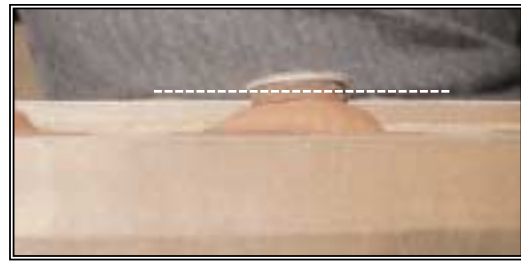
crooked valve

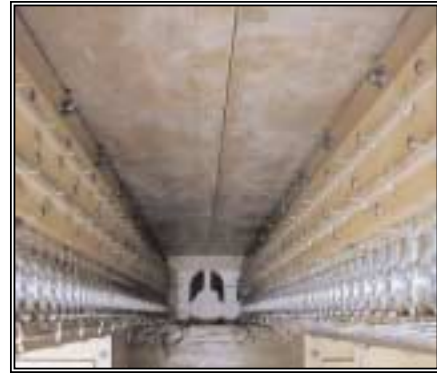
Key primary actions of the Pedal and upper Great pitman windchests. The mufflers have been removed. Note new magnets (shiny metal units)

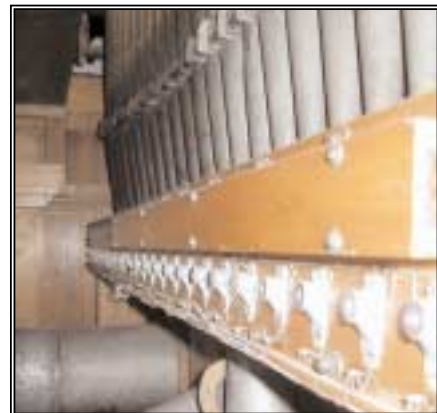
This offset windchest carries the tallest pipes of the Choir 16' Flûte conique. One valve muffler cover is in place; both magnet mufflers has been removed.

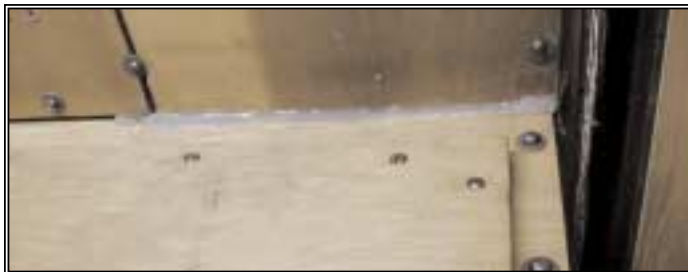
Windchest restoration goes beyond re-leathering to re-gasketing and concern for windtightness. The application of silicone sealant shown above is an expedient means of address leaks, which should have been addressed with re-gasketing.

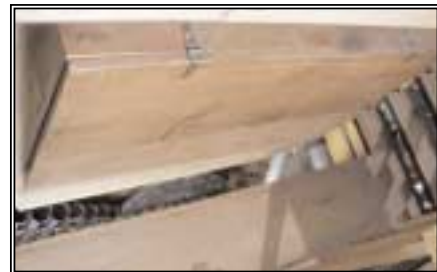
The Vox Humana chest, with its front lid closed. This chest does not function properly, and is probably best replaced.

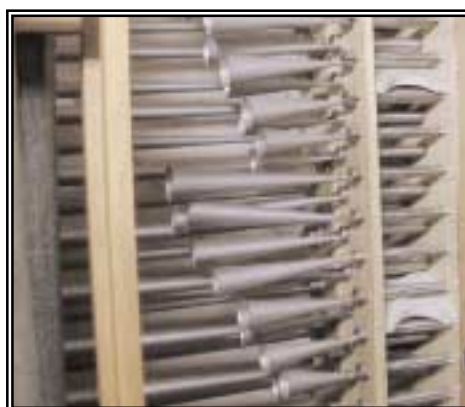
The chests for the Pedal Flute and Swell mutations appear to be in decent shape. However, the Chamade chest is a potential hazard. It seems inadequately installed, and sways from side to side. In a perfect world, a better location would be found for this stop; or it would be removed altogether.

This picture does not adequately demonstrate the sub-standard method with which this vertically-mounted windchest is attached to the wall and structure. The chest moves with the slightest touch.

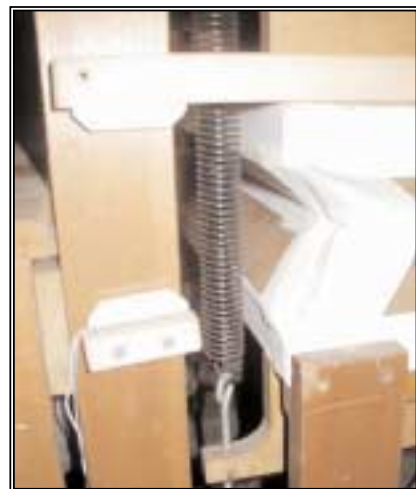
The switch that turns on the organ power?

wind is raised. I cannot be certain, but the switching of the power in this organ seems to be accomplished by a sensor of the kind you might find on a window in a home security system. This unit is crudely affixed to one of the reservoirs in the North chamber.

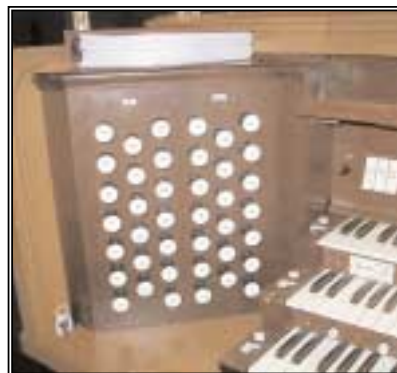
- The manual keys are significantly out of adjustment, and require overhaul.
- The ivory key coverings are in rough shape; one needs to be reapplied.
- The pedalboard needs similar reconditioning.
- The combination action seems unreliable, relating possibly to battery failure in this era of Peterson unit.
- The drawknob solenoid units are of an early unperfected type. While they work adequately, better units have been developed since 1970, notably those from Harris Precision Products.
- The expression pedals are in good condition.
- The console shell is in good condition, and needs only minor touch-up to restore and preserve its original elegance.

The console's condition leads to an inescapable conclusion: the console should be entirely rebuilt, in the spirit of the 1970 work but to a standard equal to that of 1935. Such a rebuilding would entail new keyboards, stopjams, nameboard and tablet rail. The lower portion of the console can once again be refurbished and reused. A new multi-level solid-state combination action should be incorporated into this work, in a project paired to a new, unified electronic control system for the entire instrument. This would put all organ control systems on a fresh, reliable footing, eliminating the current patchwork of original and later equipment.

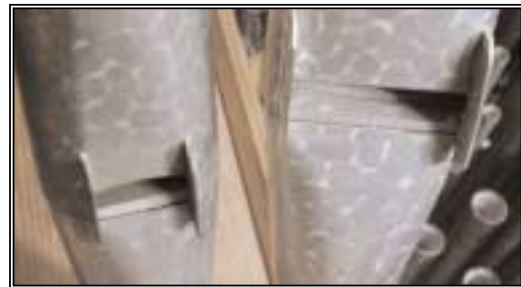
LEFT Flauto Dolce pipe with original languid and nicking
RIGHT Geigen pipe with new languid and sparse nicking

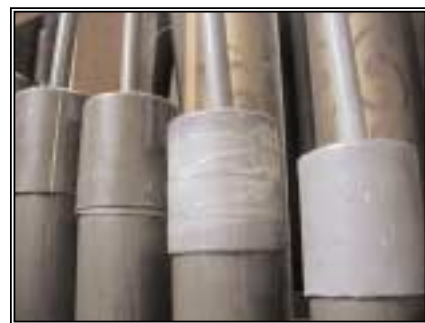
The original Swell Rohrflöte is now in use as the Pedal 4' Flute. "Rohr" is German for chimney, hence the thin tube atop each pipe. The canister caps have loosened with age. Shipping tape has been used to tighten this particular pipe.
