THE
Aeolian-Skinner
Organ

Calvary Church

MEMPHIS, TENNESSEE

Site survey conducted 15-17 April 2001
Draft report submitted 10 October 2001
Final report submitted 31 October 2001

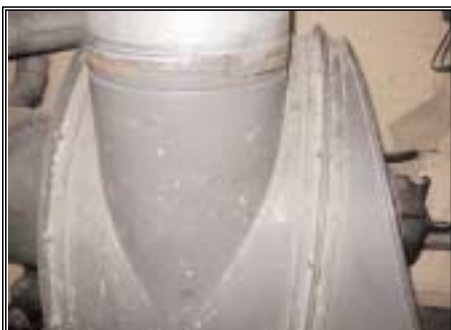
ABOVE
blower room junk

The blower environment is poor, primarily because the room is being used as a junk pit. All manner of foreign items are stored here. An excellent first step would be to clean out the junk pile, then perform a thorough vacuuming and damp-wiping. After cleaning, a filter could be fitted to door intake, to ensure that the organ breathes clean, dust-free air.

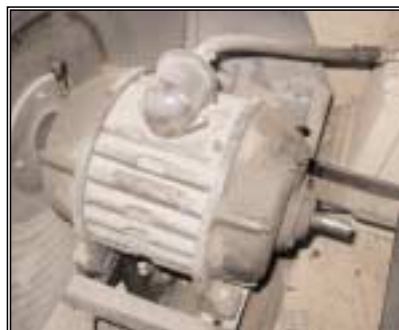
A Spencer Orgoblo blower was provided new in 1935. This is a turbine-like machine with several large fans driven by an electric motor. Spencer blowers are exceedingly well made, and with proper care will last indefinitely. This one runs somewhat hot and cranky, with considerable vibration that indicates a balance problem. I'm not a motor specialist, so cannot diagnose whether the problem comes in the bearings of the motor or in the balance of the fans. The situation deserves further diagnosis.

FAR LEFT
Spencer blower

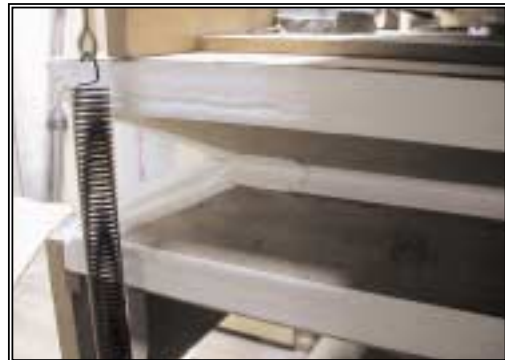
recent bellows recovering work

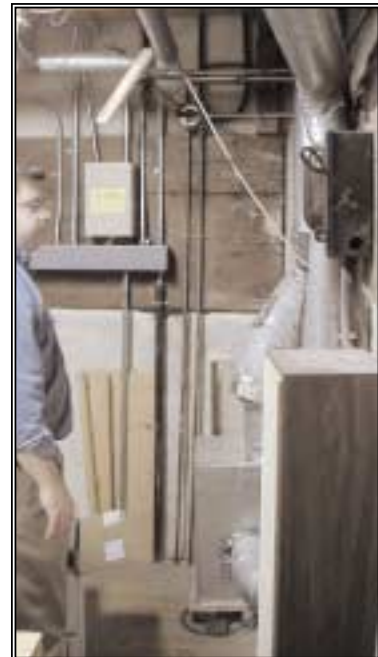
VENTILATION SYSTEM: Sometime after 1984 a ventilation system was added to each chamber, presumably to better balance each chamber's temperature in an attempt to stabilize side-to-side tuning. At first glance it is hard to know the precise goal of the system, but one logical guess would be that the chambers tend to stay cold in winter, hot in summer. By circulating air, ambient conditions are drawn in from the sanctuary and bring the organ to temperature, and thus to pitch. One of the troubles of such a system, however, is that the circulation of air often leads to the increased distribution of airborne dust particles. Only long-term observation can determine the effects of this system.

ventilation system in South chamber

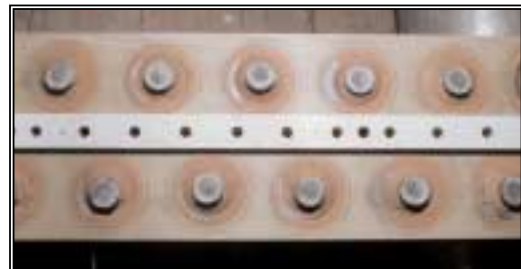
PITMAN CHESTS Most of the pipes are planted upon the original 1935 Aeolian-Skinner windchests. Underneath each note of every stop is a leather pouch and valve. The leather varies in thickness depending on the application, but is essentially that of fine ladies' gloves: about as thick as a few sheets of this report. As the organ is played, the leather pouches constantly flex. Just one church service entails thousands of individual pouch movements. As the leather decays, it develops punctures, causing notes to go silent or, worse, sound all the time. These unwanted alleluias are called "ciphers."

typical pouchrail inside a pitman windchest

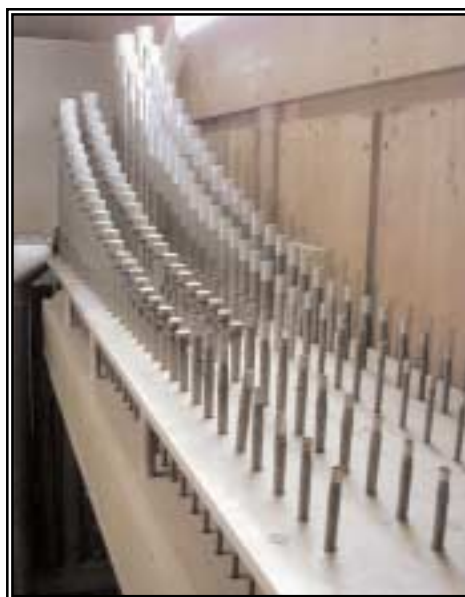
The added chest in the Swell, carrying the Nazard and Tierce pipes. This windchest was built by Reuter and installed in 1984.

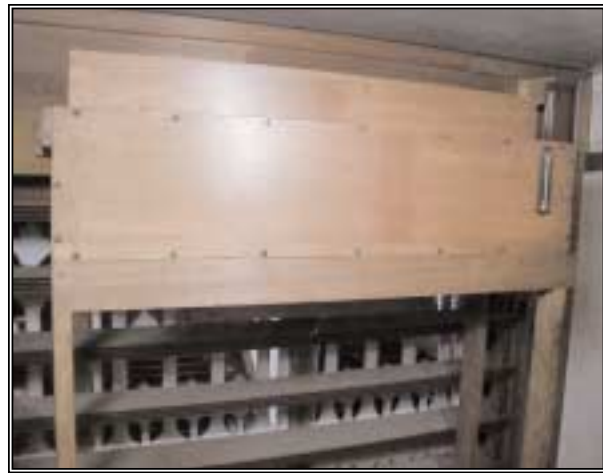
Original whiffletree motor in the Swell; swell shades behind

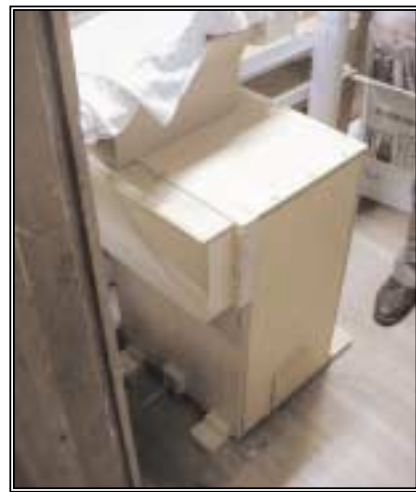
New swell engine in Choir

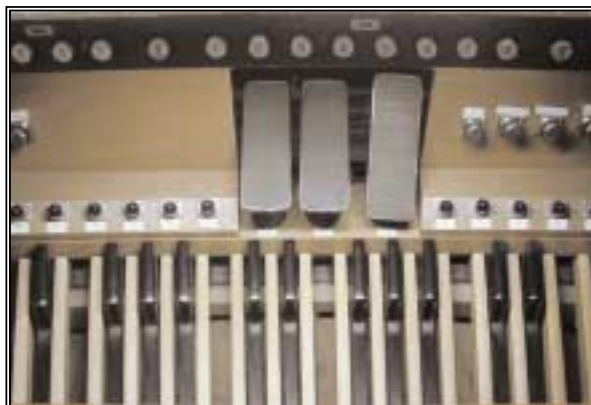
The pedal keys, toe terraces, toe studs and expression pedals appear original; newer toe studs have replaced the original kick pedals.

- The manual keys are significantly out of adjustment, and require overhaul.
- The ivory key coverings are in rough shape; one needs to be reapplied.
- The pedalboard needs similar reconditioning.
- The combination action seems unreliable, relating possibly to battery failure in this era of Peterson unit.
- The drawknob solenoid units are of an early unperfected type. While they work adequately, better units have been developed since 1970, notably those from Harris Precision Products.
- The expression pedals are in good condition.
- The console shell is in good condition, and needs only minor touch-up to restore and preserve its original elegance.

The console's condition leads to an inescapable conclusion: the console should be entirely rebuilt, in the spirit of the 1970 work but to a standard equal to that of 1935. Such a rebuilding would entail new keyboards, stopjams, nameboard and tablet rail. The lower portion of the console can once again be refurbished and reused. A new multi-level solid-state combination action should be incorporated into this work, in a project paired to a new, unified electronic control system for the entire instrument. This would put all organ control systems on a fresh, reliable footing, eliminating the current patchwork of original and later equipment.
